**Re: Response to EPA Analysis of the *Final Habitat Mitigation and Monitoring Plan*, dated September 12, 2017, EPA Comments October 5, 2017 (Revised November 30, 2017)
Rosemont Copper Project, Clean Water Act Section 404 Permit, CoE File No.: 2008-00816-MB**

Rosemont – Response to EPA HMMP Comments

**"The Mitigation Proposed by Rosemont Mine
Will Not Offset Impacts to Waters of the U.S.
below the Level of Significant Degradation"**

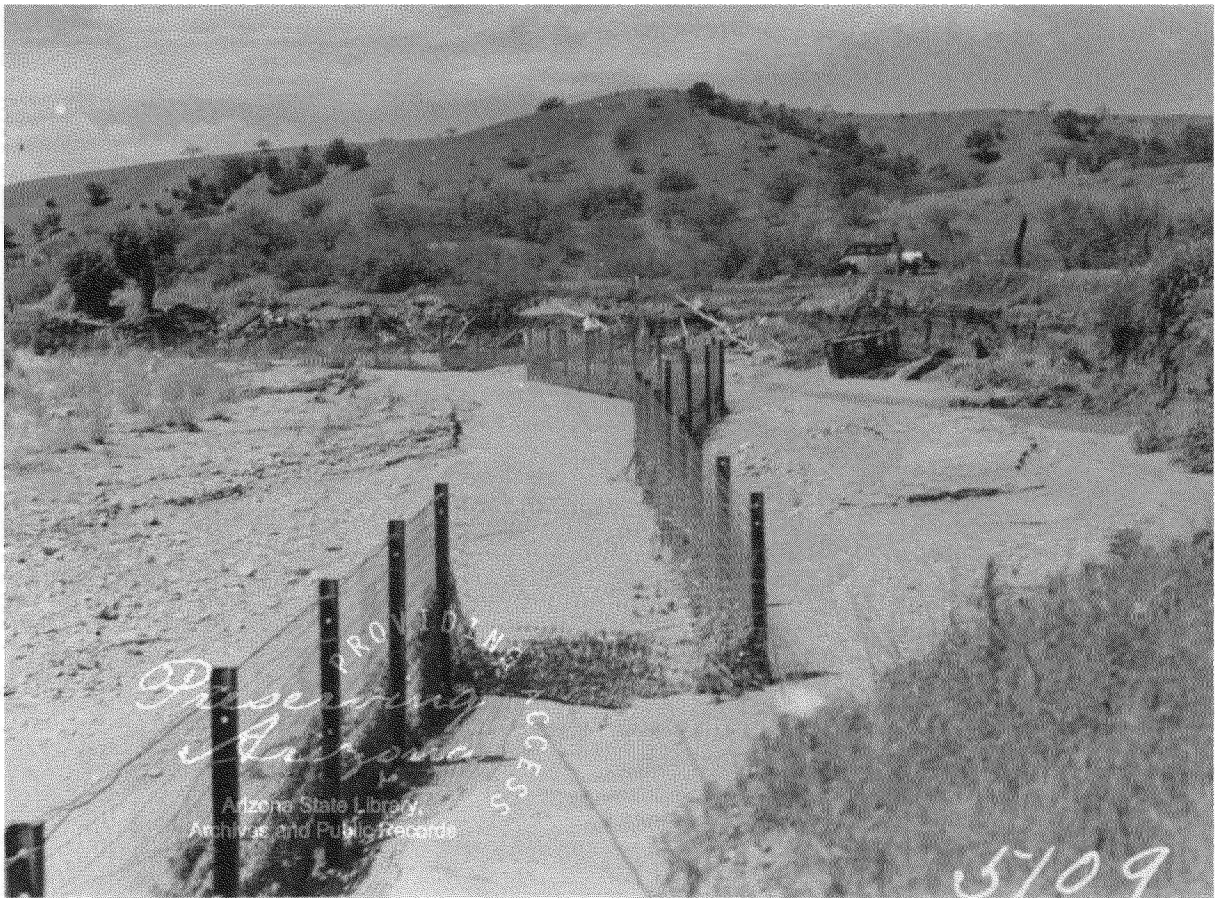
Photo 1. Late 1930s View of Erosion Control Works along Sonoita Creek in the Vicinity of Rail-X Ranch

As described previously, Anglo-American water management policies and practices lead to widespread downcutting along the Santa Cruz River, and there is evidence that similar changes had occurred along Sonoita Creek by the 1930s. A photograph believed to have been taken in the late 1930s in the vicinity of Rail-X Ranch shows that the stream had downcut and become incised by this point, and work was underway to construct gabions to reduce further erosion and protect State Route 82 (SR 82) (**Photo 1**). This shows that at least 60 years of Hispanic and Anglo-American water management practices had created an incised stream along this stretch of Sonoita Creek.

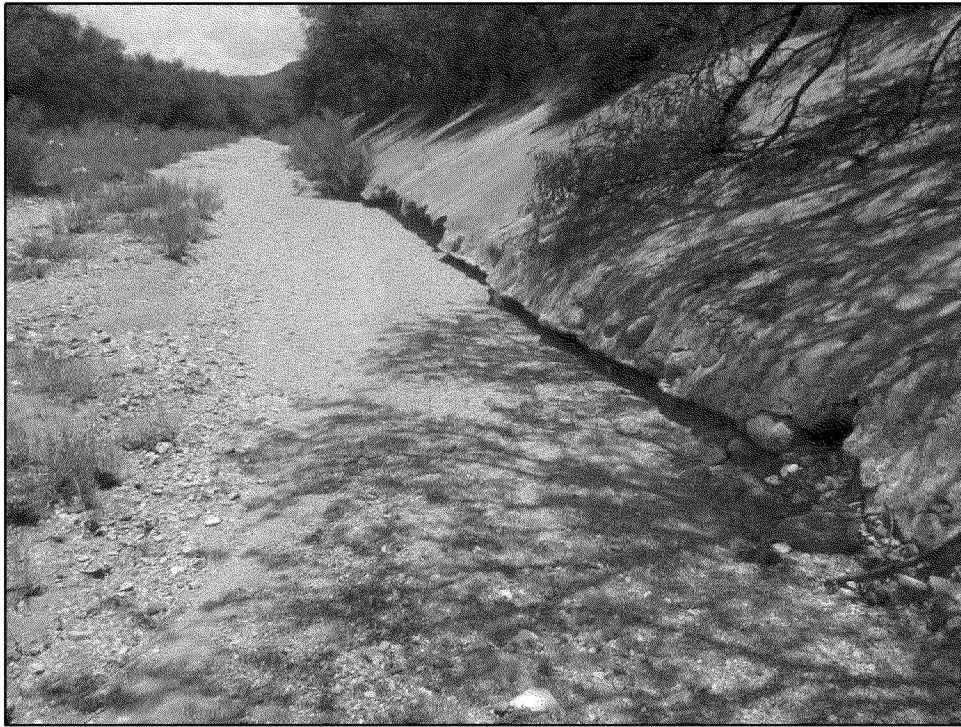
Photo 2. Facing Downstream in Sonoita Creek at SCR with Concrete West Bank

The HMMP extensively details the reasons to reestablish Sonoita Creek to a central position in the valley. The present-day location and layout of Sonoita Creek at SCR on the western edge of the valley is a result of a historic realignment and straightening to accommodate agricultural and infrastructure development, and may well be the remnants or alignment of a 19th-century irrigation ditch (see historical discussion in **Section 2.3**). Sonoita Creek is artificially constrained between the highway and a gas pipeline; this location exacerbates erosion and incision while precluding the development of even minor amounts of channel complexity and an irregular meander pattern found in natural settings as described by the EPA (2017). The Sonoita Creek reaches at RX Ranch and SCR Ranch show clear and extensive evidence of manipulation and include multiple hydraulic structures (concrete channel walls, gabion baskets, car bodies, etc.) designed to armor channel banks and prevent channel migration (**Photos 2 and 3**). These hardened bank structures increase flood velocities, prevent establishment of riparian species and establishment of a functional floodplain, and reduces channel complexity (Florsheim, Mount, and Chin 2008).

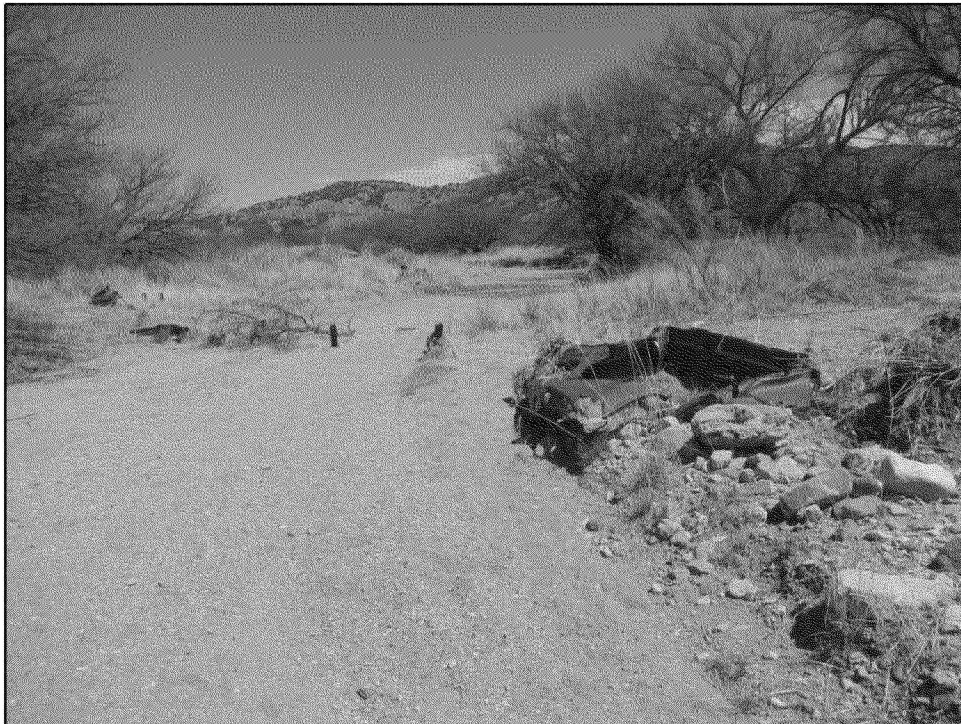
Photo 3. Car Body and other Historic Hydraulic Structures

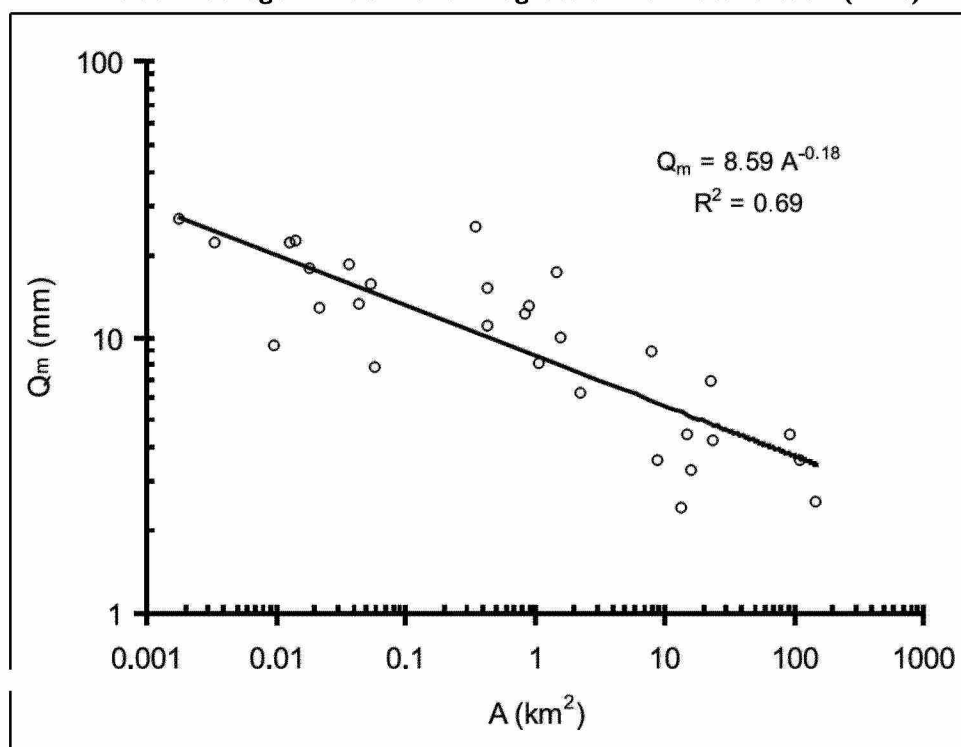
Exhibit 5. Average-Annual Runoff Regression from Stone et al. (2008)

Note: The equation depicted in the preceding figure for average-annual runoff per unit area is: $Q_m = 8.59A^{-0.18}$, where the units of runoff (Q_m) are average depth in millimeters per unit area (square kilometer), and the units of area (A) are in square kilometers.

In English units, the equation in **Exhibit 5** is: $Q_{AFA} = 15.20A^{-0.18}$, where Q_{AFA} is the annual runoff in acre-feet per unit area (square mile), and A is the watershed area in square miles. Assuming $A = 14$ square miles (the total size of the Rosemont watershed at the USGS SR 83 streamgage, not subtracting areas reporting to stock ponds) the resulting value of AFA per square mile, in English units, is: Q_{AFA}
